## Placement of 1 monobloc zirconia implant

Z-Systems z5m implant system

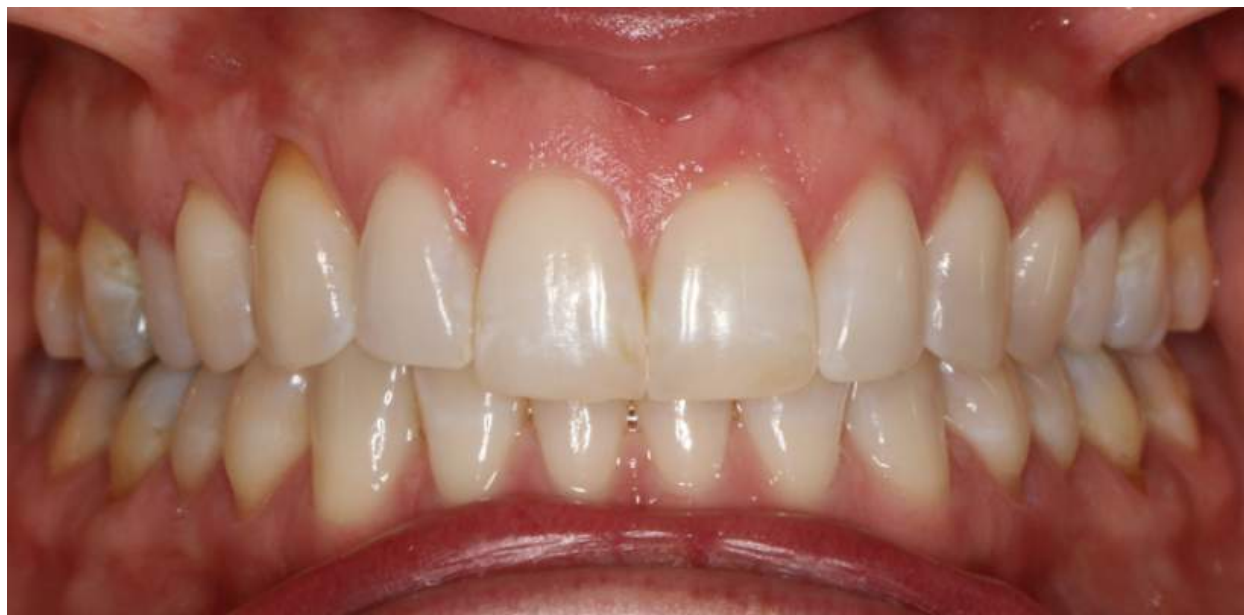
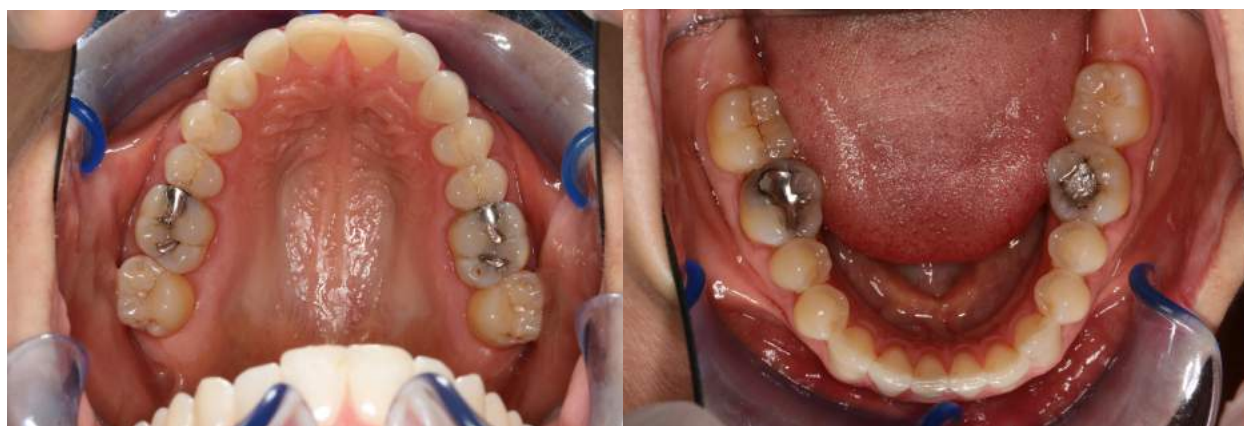
34 yr old female presented in 2014 with history of recurrent joint infections, increased ASO antibodies, chronic low grade fever, and poor digestion. Orofacial and radiographic examination revealed failed root canal treated tooth #6 with mild periapical bone loss and a 15mm spherical area of decreased bone density where #1 used to reside. Multiple dissimilar metals, including mercury were also present.

Fig. 1: Pretreatment photographs

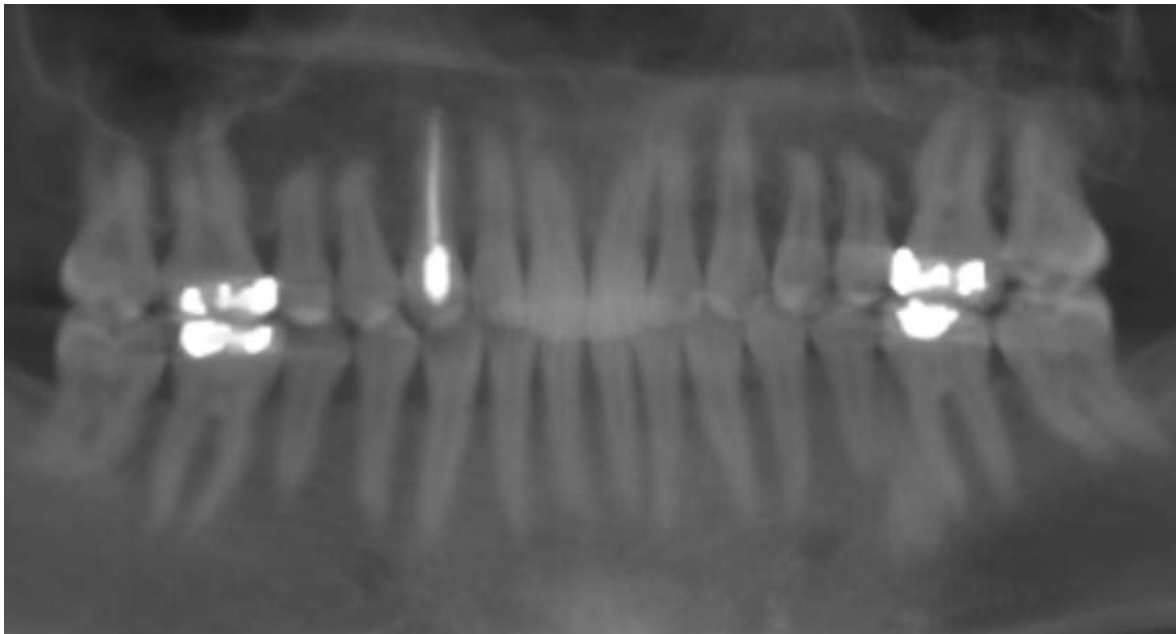
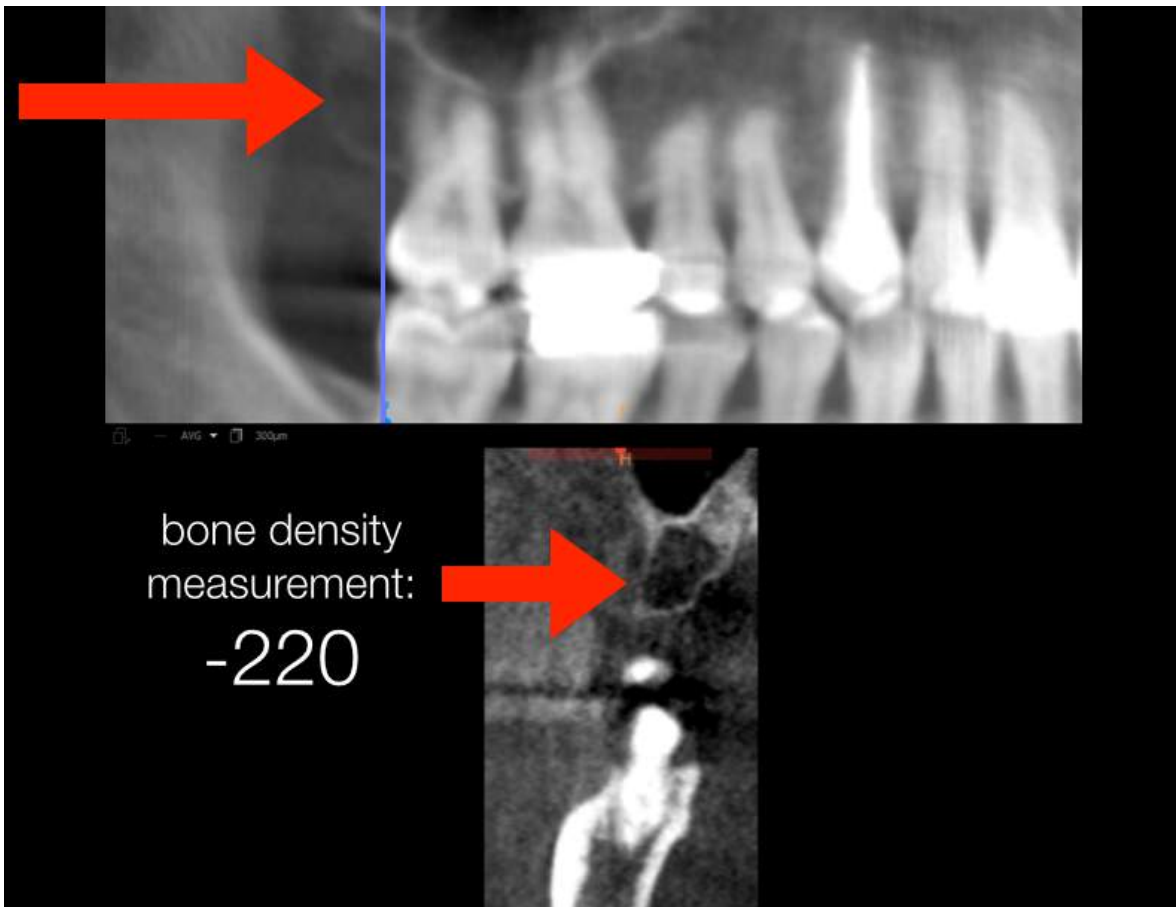
Fig. 2: Pretreatment radiographs from Kodak 9500 cbct

#6 was surgically removed, being careful to remove all diseased tissue and PDL fibers with ultrasonic piezotome and ozonated saline. PRF was used to graft the extraction site. #1 area was also biopsied, surgically debrided, flushed with ozonated saline, fumigated with ozone gas, sanitized with the Er:YAG laser, and grafted with PRF. All metals were safely removed and replaced with bonded restorations.

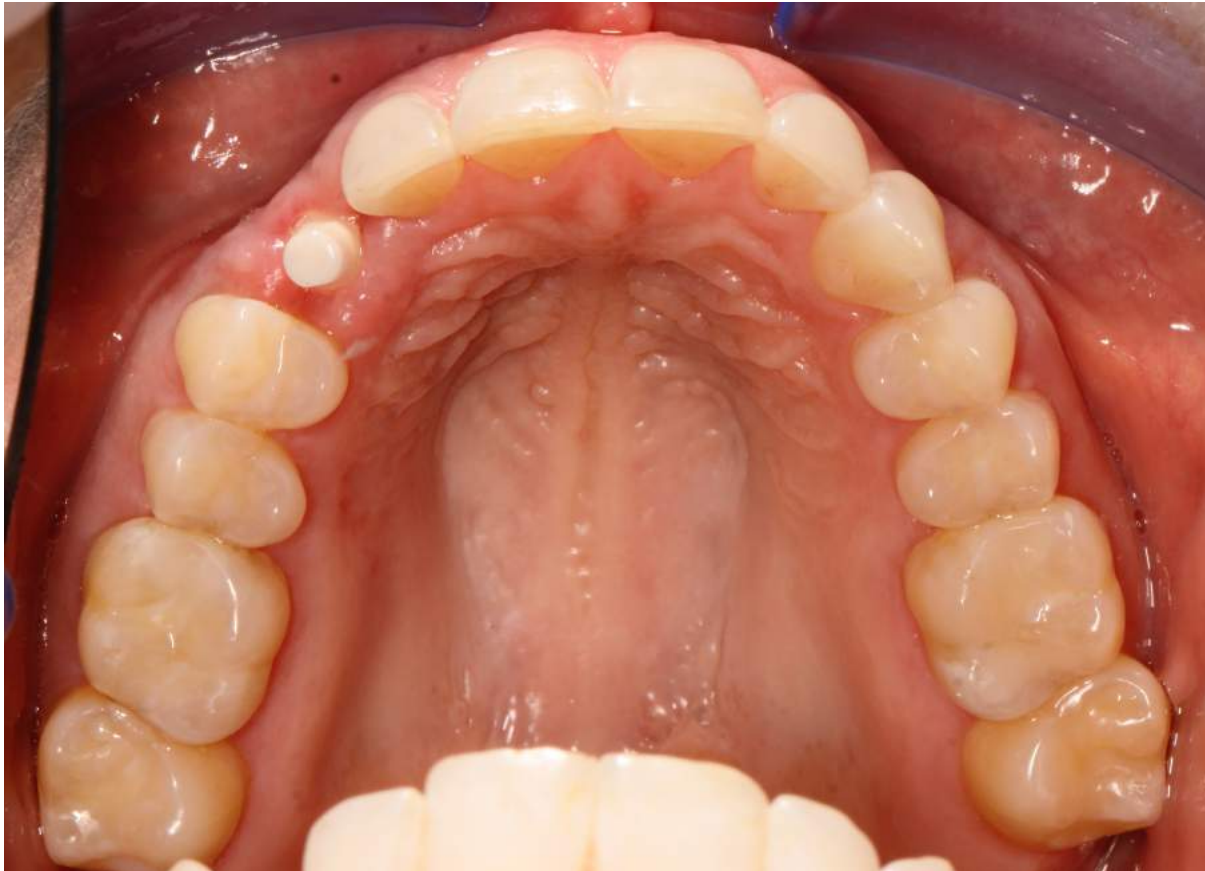
*Fig. 3: 1 week post operative photograph*

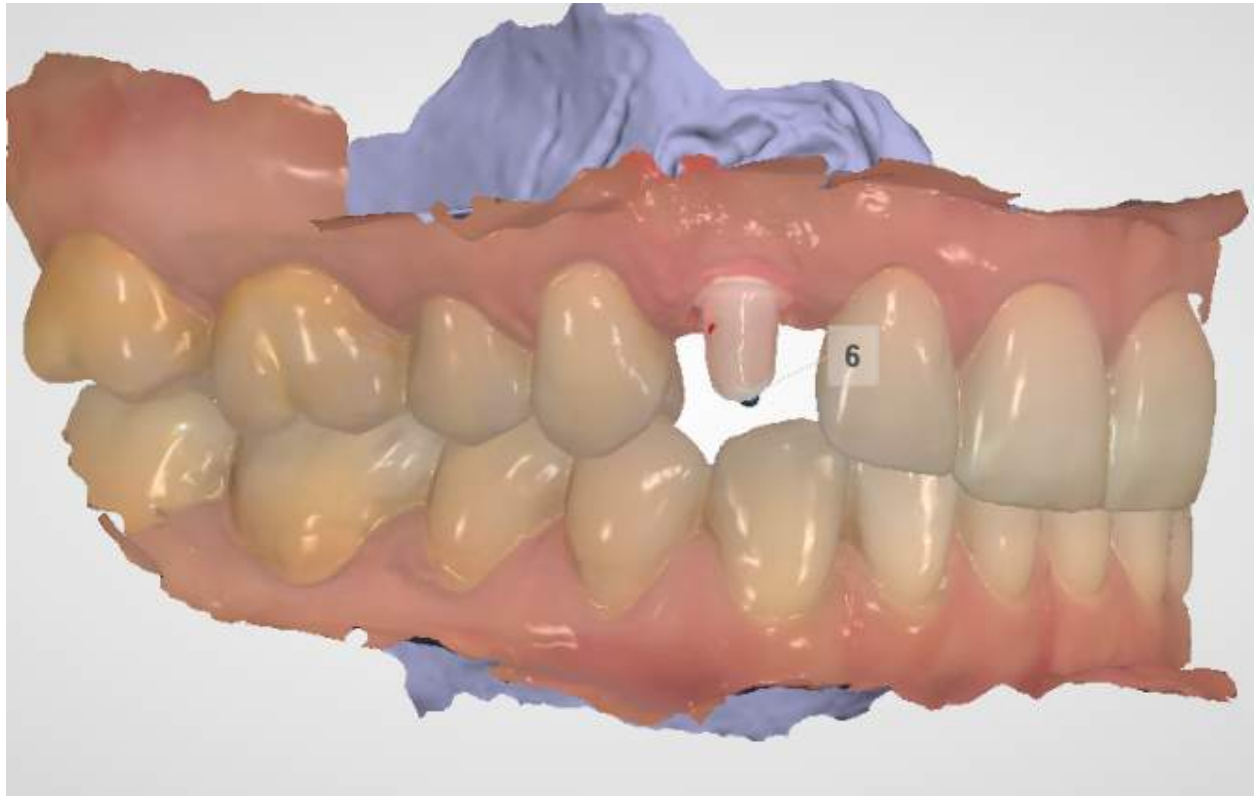
#6 implant was scanned with the Trios system. The scan was milled in-house with the AmannGirbacch Ceramill 2 cad/cam system. Patient reports significant decrease in joint pain and improved digestion.

Fig. 4,5: 3 Shape Trios digital impression (upper image) and CeramillMind cad/cam design (lower image)

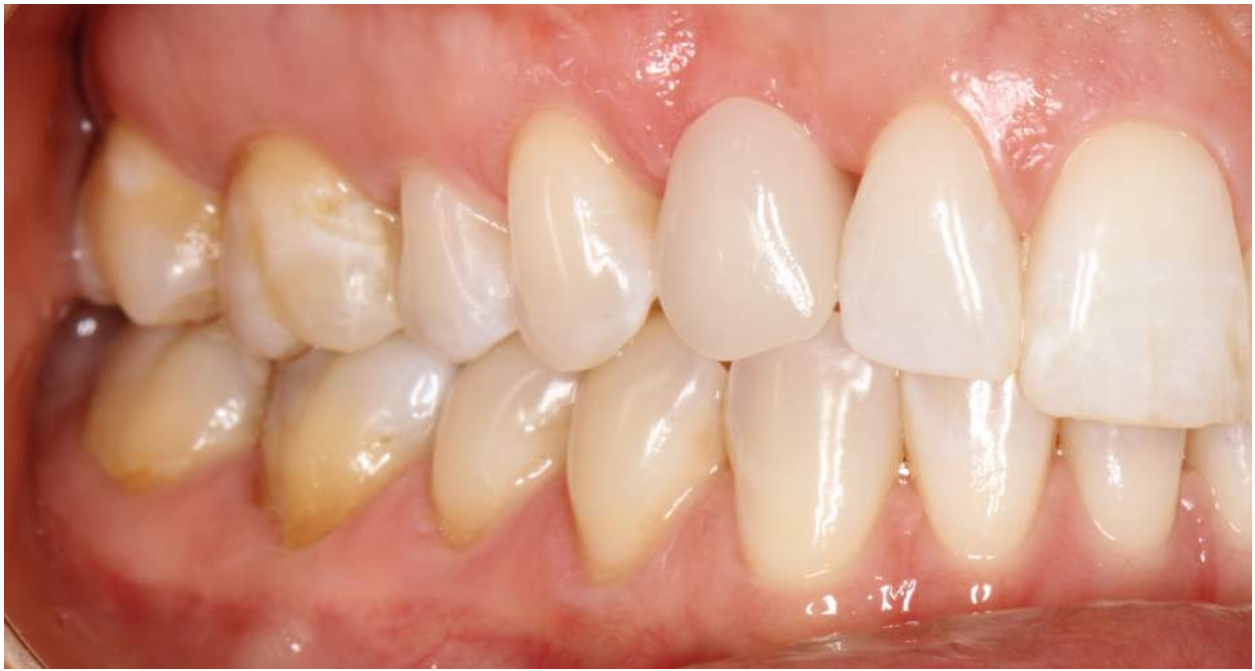
*Fig. 6: finished case, #6 eMax crown in vivo.*

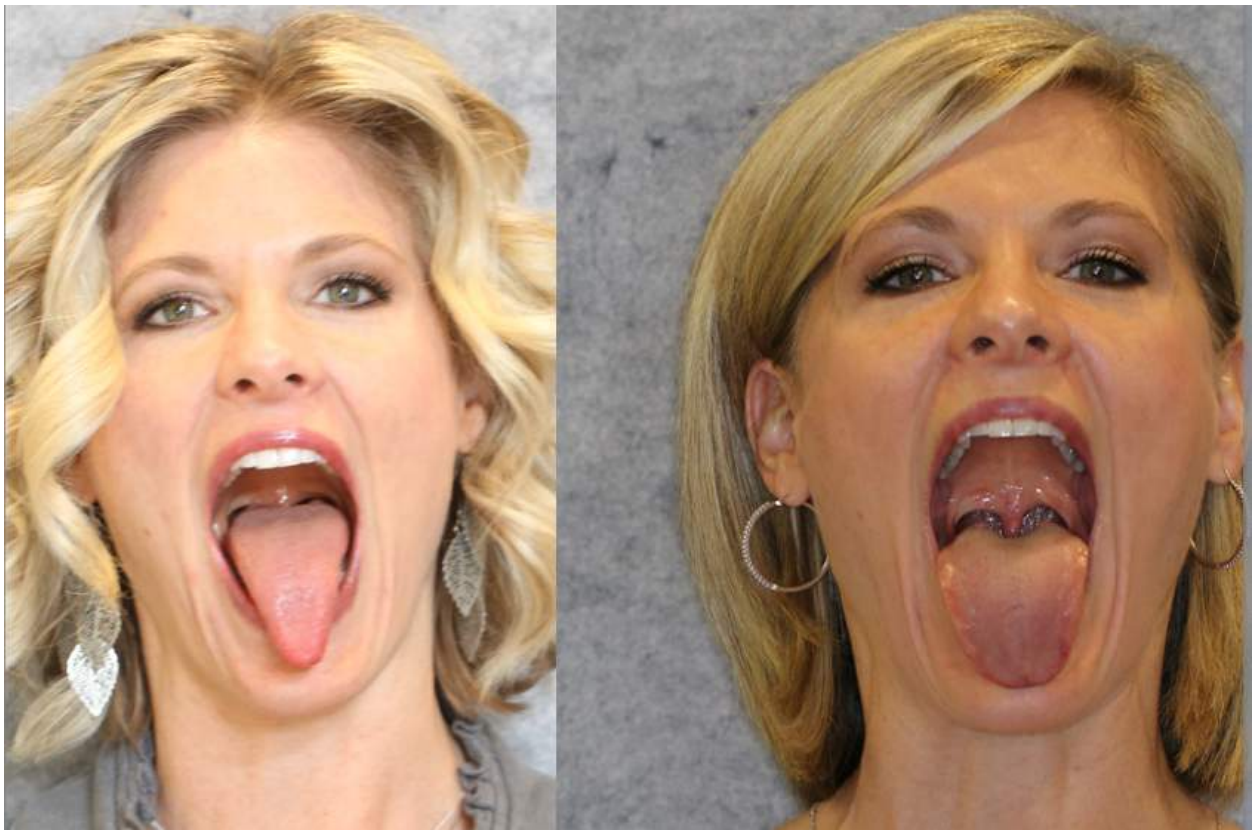
*Fig. 7: patient's tongue after treatment, left and before treatment, right*
