Placement of 10 monobloc zirconia implants

Z-Systems Z3 ball implant overdenture system

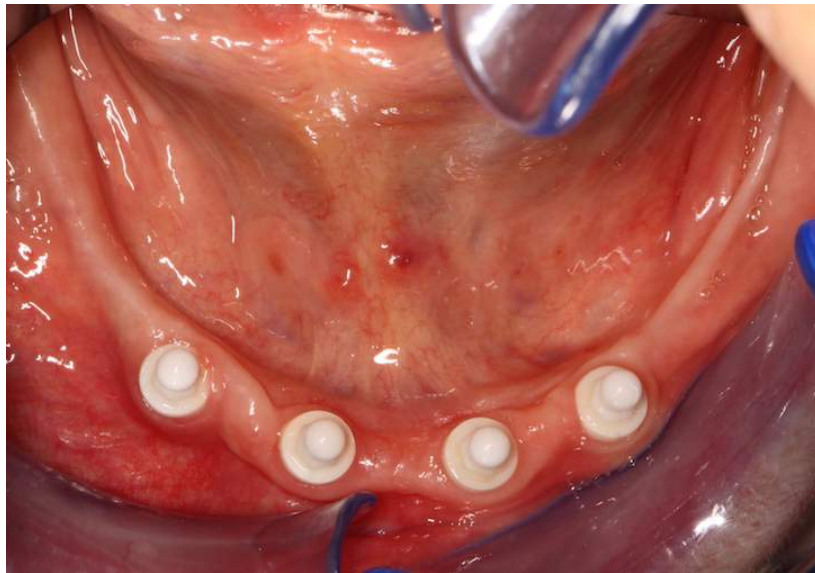
Fig. 2: Z3 lockball implants in situ

#31 was surgically removed, and complete dentures were fabricated. Z3 4x11 lockball implants were placed in areas ##2,6,8,11,14,22,24,25,27. Dentures were blocked out to prevent micro movement.

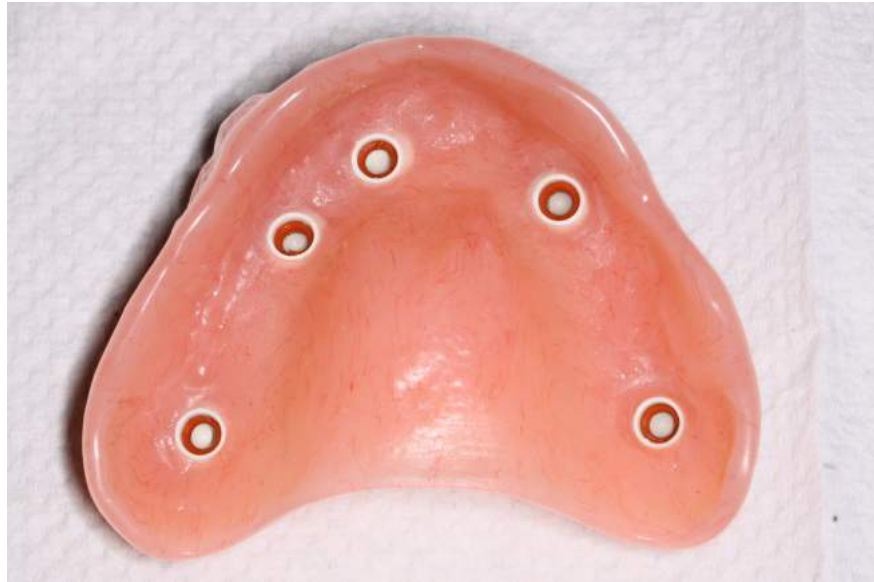
Fig. 3: tissue side of upper complete implant supported denture

After 3 months, o-ring housings were added to the dentures. Bite was balanced, as necessary.

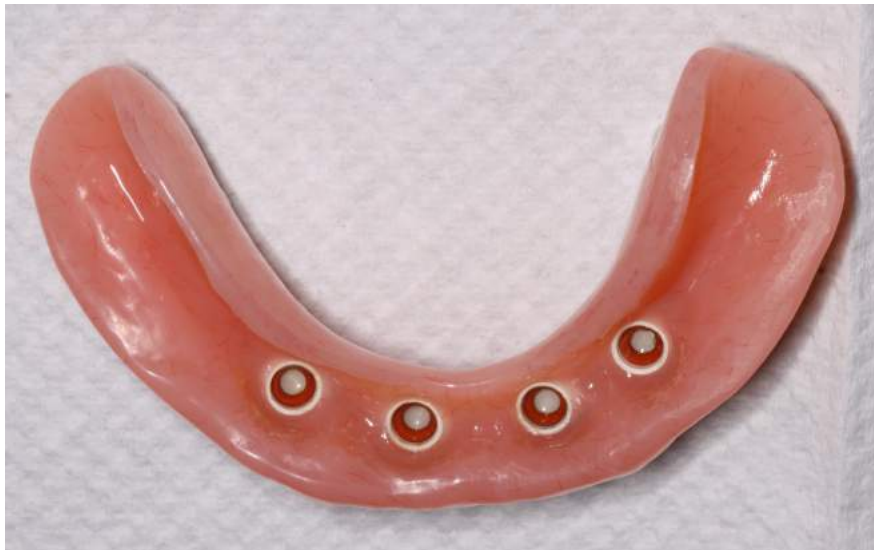
Fig. 4: tissue side of lower complete implant supported denture
